U.S. Department of Transportation  
Federal Highway Administration-  
California Division- Title 23  
Damage Assessment Form (DAF)

**Engineer's Estimate**  
**Creekbank Slope Repair Project, San Francisquito Creek at Woodland Avenue**  
**CITY OF EAST PALO ALTO, CALIFORNIA**

Engineer's Estimate  
Site #1 Creekbank Slope Repair (CIDH roadway edge support)  
Woodland Avenue Upstream of University Avenue  
East Palo Alto, California

Re: Preliminary Geotechnical Investigation and Conceptual Recommendations  
Permanent Restoration- CIDH (Cast-In-Drilled-Hole) - Creekbank Slope Repairs  
Woodland Avenue Upstream of University Avenue (List of Projects, Site #1)  
City of East Palo Alto, California

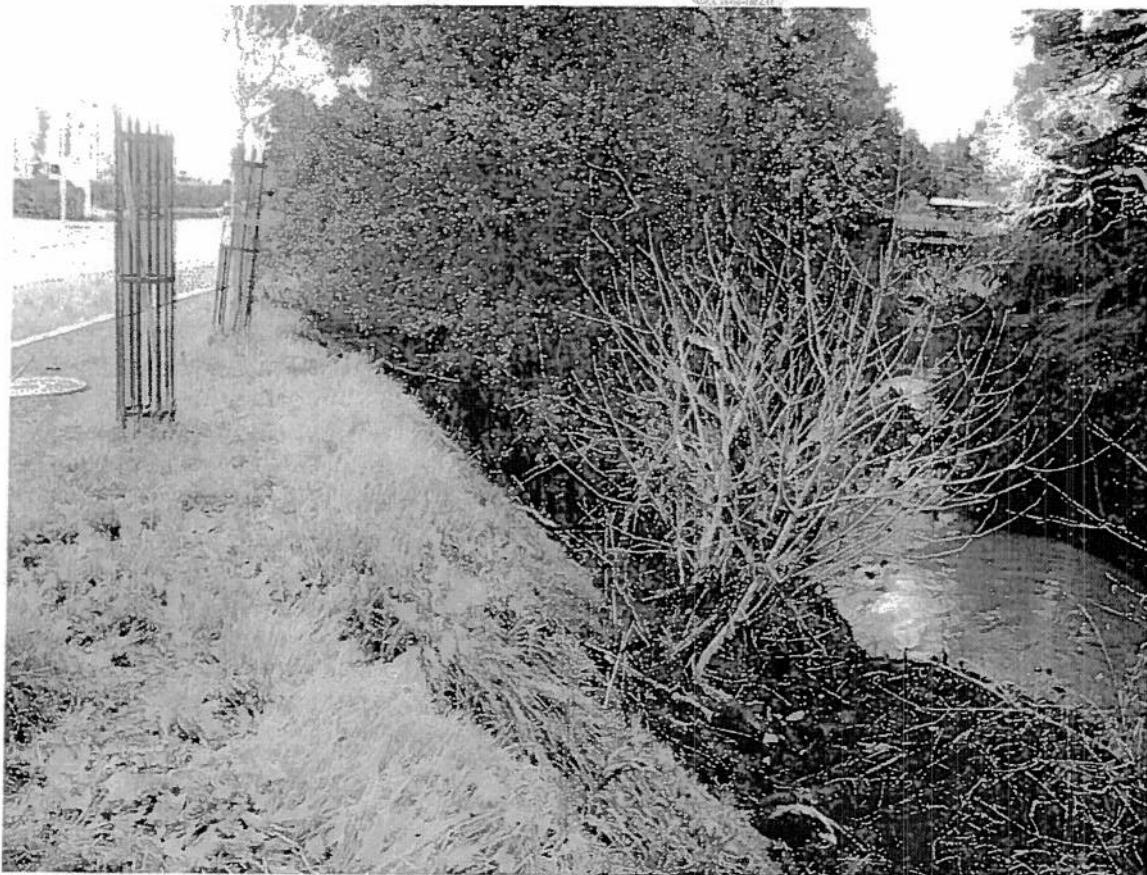
horizontal surface between the concrete curb and gutter and the top of bank along the north side of the San Francisquito Creek varies in width between approximately 5 and 10 feet as shown on Photo 1. A shallow failure, estimated at a maximum five feet deep occurred during the December storm event as shown in Photo 1. "Tension cracking" as shown in Photos 2 and 3 also occurred over a distance of perhaps 150 to 200 feet as shown on Figure 2. The maximum width of the cracks was perhaps ½-inch and there was little, if any, vertical offset across the observed cracks.

Photo 1: Creekbank just west (upstream) of University Avenue Bridge. Note steepness of slope and proximity of the creekbank to the adjacent roadway. Also note the shallow "popout" / creekbank failure (middle of photo) and soil debris deposited from the failure (lower-right corner of photo). Photo from December 27, 2012.

As noted in our December, 30, 2012 letter report, Site 1 was damaged by the December 22-23 storm event as demonstrated by the sloughing shown in Photo 1 (above) and tension cracks shown in Photos 2 through 4. While there has been no noticeable damage at this time to either the joint trench at the back of curb or paved Woodland Avenue, the steepness of the creekbank, "erodibility" of the creekbank soils and new movement has decreased lateral confinement and additional losses will threaten stability of the adjacent improvements. As shown in the Conceptual Cross Section on Figure 2 (upper right corner), the tension cracks are likely a precursor to additional "wedge failures" or sloughs of the creekbank that will lead to even steeper slopes and eventual loss of the paved roadway. So while damage appears minor at this time, we conclude the disaster has compromised the structural integrity and lateral capacity of the roadway.

- The "preferred" option to protect the roadway and utilities, in our opinion, is a cast-in-drilled-hole (CIDH) concept that is shown on Figure 2. This option, while costly, would likely be half the cost of the sheetpile option and yet nearly similar levels of improvement. This option would include drilling relatively closely-spaced piers along the top of creekbank, dropping a reinforcing cage into the piers and filling with concrete. The upper four to five feet of the CIDH piers would be structurally connected with a reinforced concrete "grade beam". The work area would likely be from the upstream, northern bridge abutment and about 350 feet upstream as shown on Figure 2. 18-inch drilled piers would likely range in depth from 25 to 30 feet and be spaced at six feet on-center, although this "preliminary" design would need to be evaluated and value-engineered to develop the most cost effective structural system.

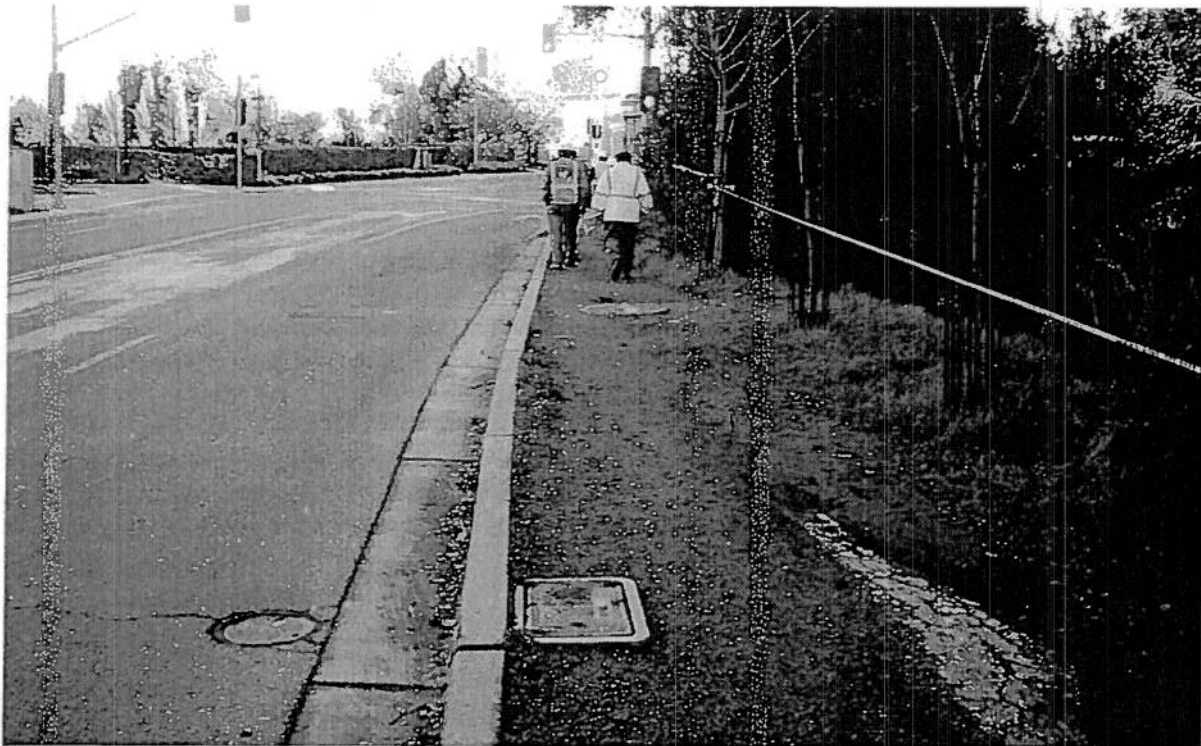
Photo 2 - View to east (downstream) along Woodland Avenue. Note the tension crack in the "shiny" area of the gravelled path adjacent to the concrete Christy box. The signalized intersection is the entrance to the Four Seasons Hotel/Business Park on the north side of Woodland Avenue.

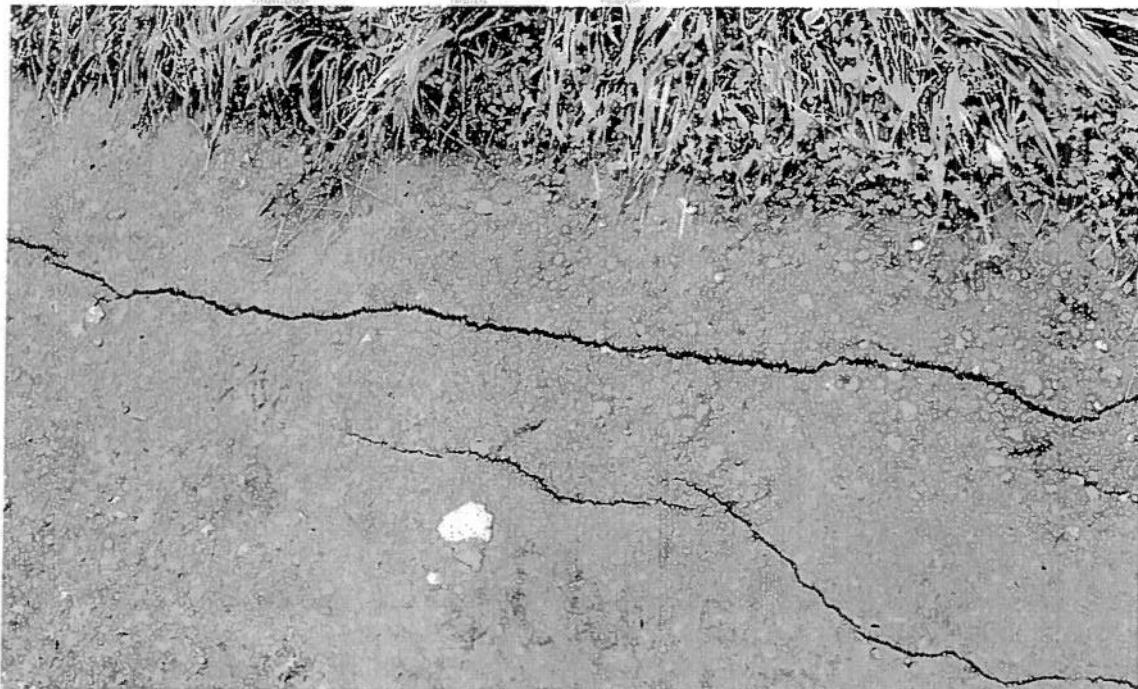
Photo 3 - Close up view of "typical" tension cracks parallel to top of creekbank along Woodland Avenue upstream of University Avenue. Photo taken on December 27, 2012.

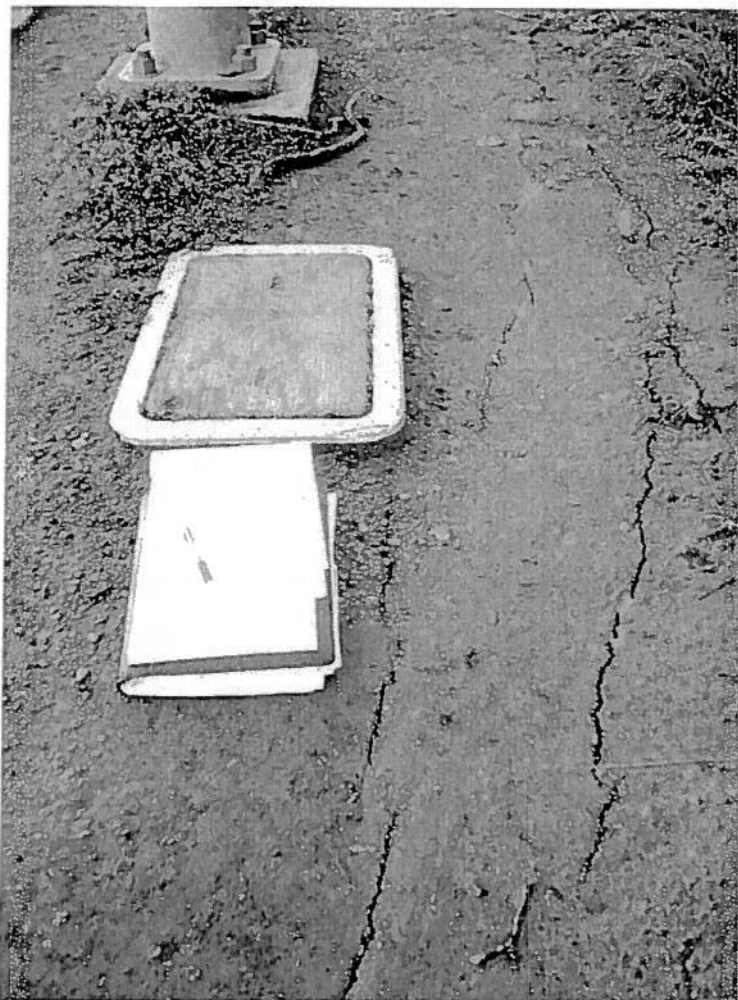
Photo 4 - Typical tension cracking along the sidewalk parallel to the top of creekbank between University Avenue and Manhattan Avenue. Photo taken December 27, 2012.
